115-32-10260 Route Correction*Stream:* 115-32-10260*Watershed:* Chilkat-Inlet Frontal Lynn Canal*USGS Quadrangle:* Skagway A-2*MTRS:* CO31S059E*Date Surveyed:* July 21, 2012

Table 1: 115-32-10260 Route Correction Survey Data

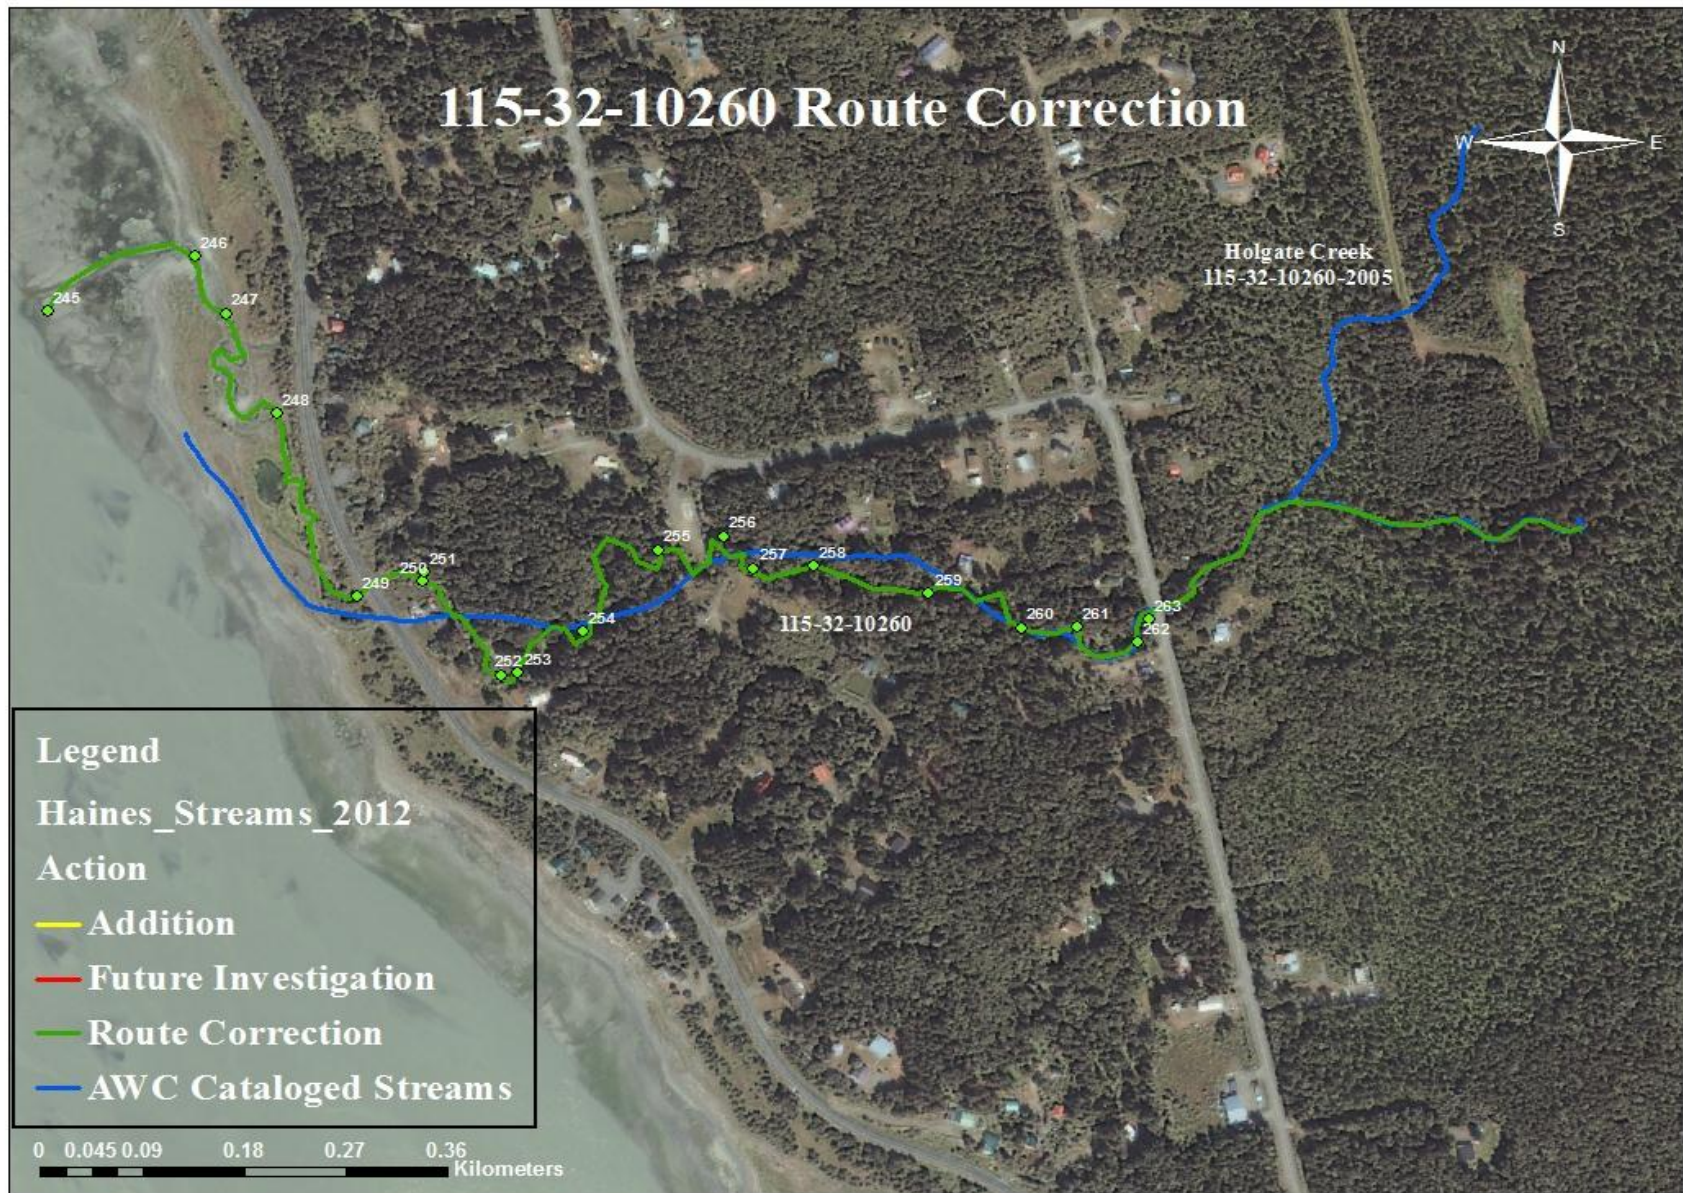
Figure 1: Map of 115-32-10260 Route Correction

Findings: The lower and middle extents of this stream differ from that illustrated in the AWC. Small personal bridges were present over the stream where it passes through personal property. We found juvenile coho salmon up to our last survey point. One juvenile chum salmon was caught at waypoint 246.

Recommendations: Update this stream route in the AWC.
